Special Report 88-3

Cold Regions Research &  
Engineering Laboratory

## *Techniques for measuring reservoir bank erosion*

Lawrence W. Gatto

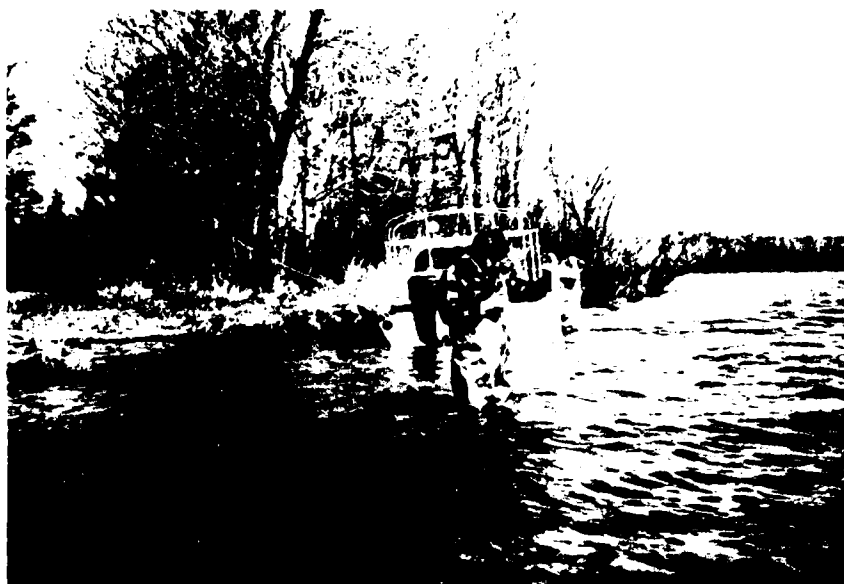
a. Measuring wave heights.

Figure 2. Spot checks of wave heights (a) and bottom changes (b).

To evaluate the erosive power of waves at a particular site, the wave heights, periods and directions can be measured using standard methods with commercially available wave gauges. Current velocities can be measured with commercial current meters. Wave estimating methods (CERC 1984) that do not require direct measurements can be used and spot checks can be made with a staff or surveyor's rod (Fig. 2a).

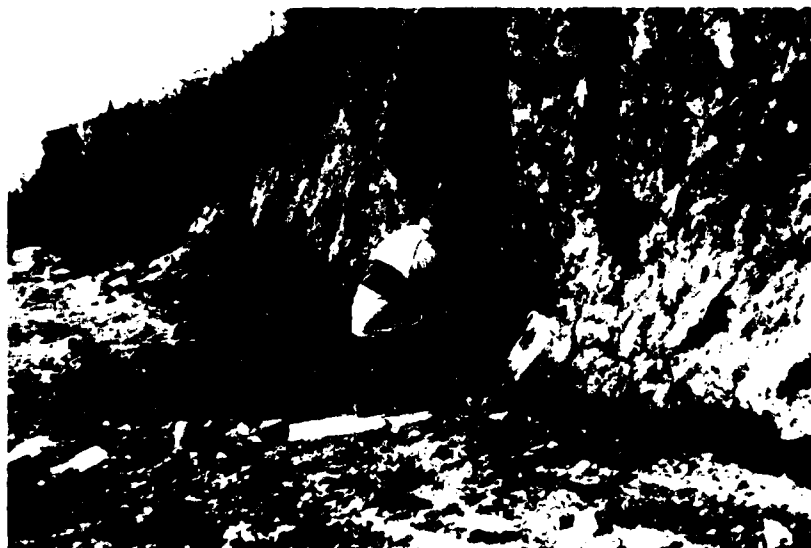
Figure 7. Plastic sheet placed at a bank toe (Reid 1984).
